Challenges with Historic Renovations

Project Example

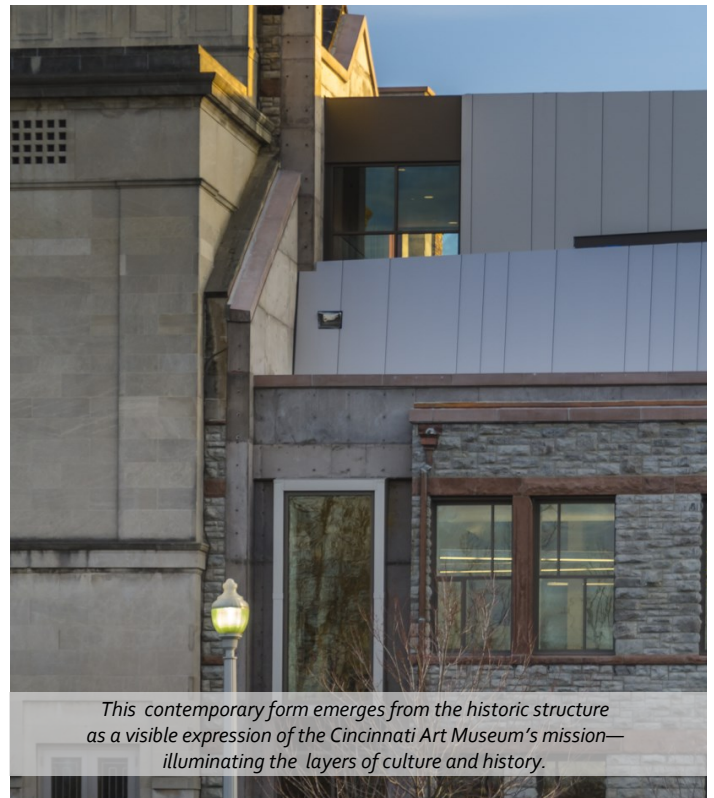
This contemporary form emerges from the historic structure as a visible expression of the Cincinnati Art Museum's mission—illuminating the layers of culture and history.

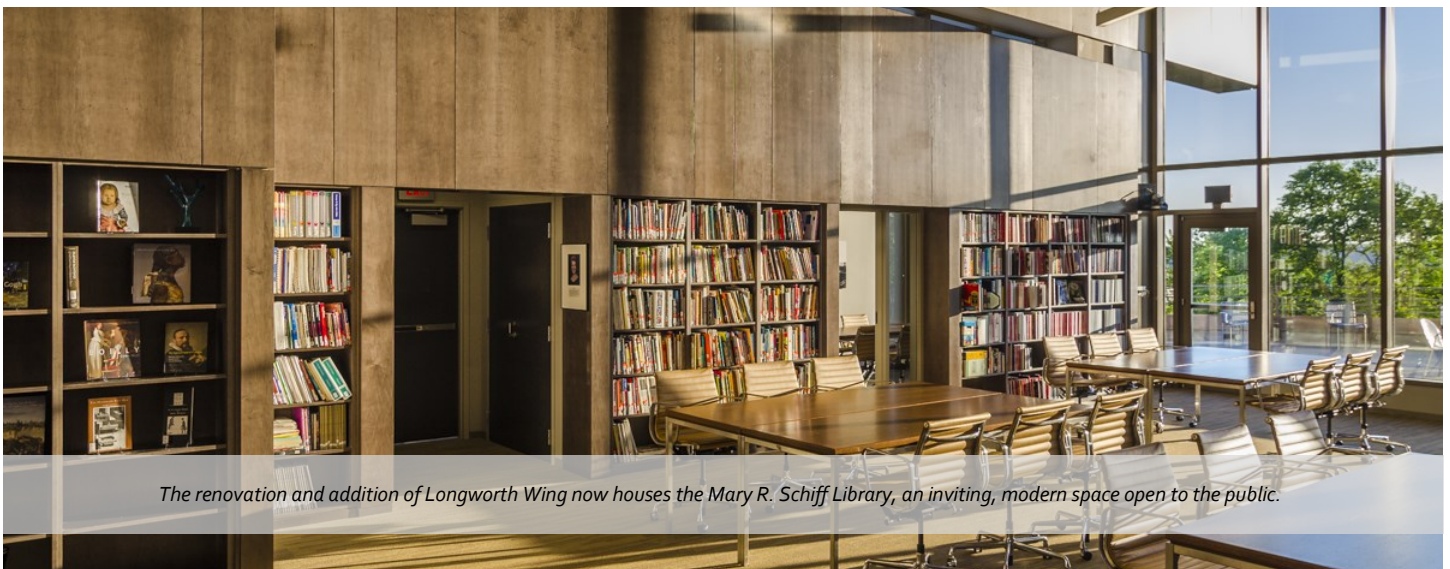
The renovation and addition of Longworth Wing now houses the Mary R. Schiff Library, an inviting, modern space open to the public.

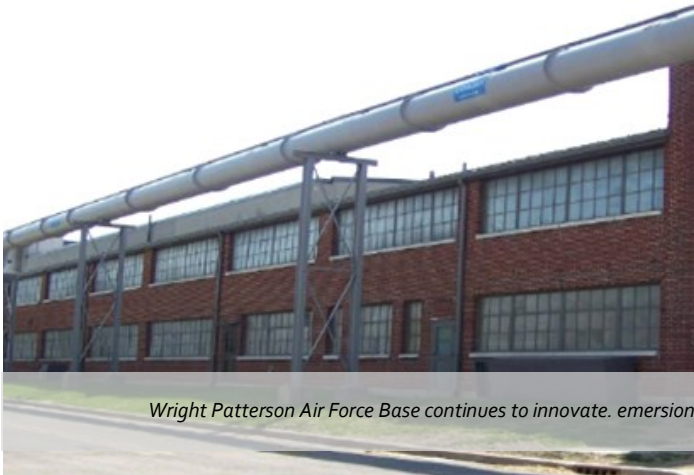
Wright Patterson Air Force Base continues to innovate. emersion DESIGN helped them install a wind tunnel inside this historic structure.

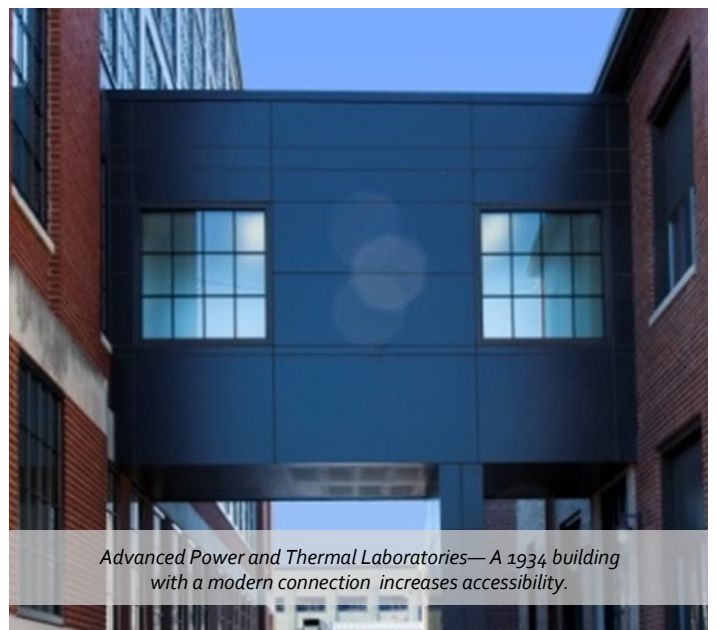
Advanced Power and Thermal Laboratories— A 1934 building with a modern connection increases accessibility.

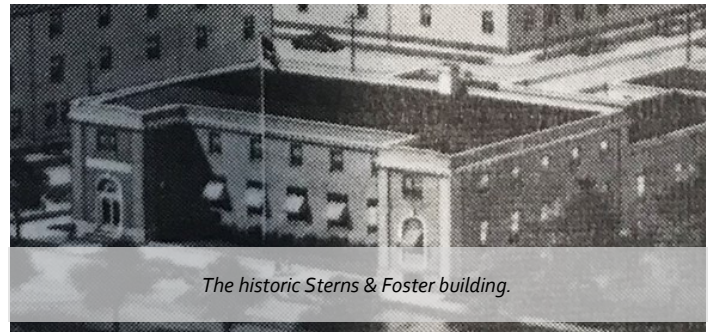
The historic Stearns & Foster building.

Stearns & Foster was founded in Cincinnati, Ohio in 1846. In 1912, they started construction on a new headquarters building in a flat-roofed brick, second renaissance revival style. More than a century later, another Cincinnati company with historic roots is bringing the forgotten landmark back to life.

The 23,000 sf Stearns & Foster headquarters building, abandoned for many years, will become Pepper Construction's Cincinnati Headquarters through an \$11 million rehabilitation and renovation. The project involves a 3rd story addition built in 1956, and three outbuildings (a garage and two sheds). While the entire building is clad in brick, there are variations in structure, materials, and finishes.

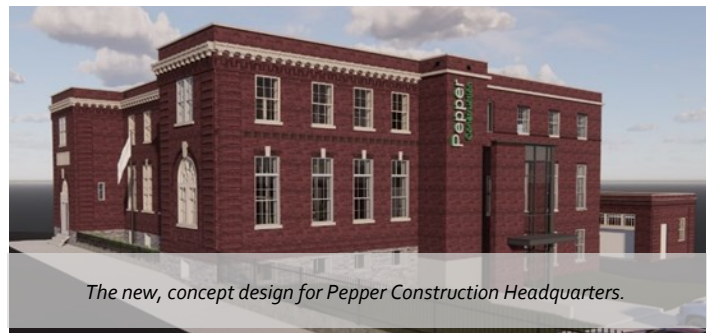
The new, concept design for Pepper Construction Headquarters.

State and Federal Historic Preservation Grants totaling \$4.5 million support the extensive scope of work that includes a complete rehabilitation of the office building with the addition of a new, compatible entrance pavilion on the south side, the rehabilitation of a garage and the demolition of the two sheds.

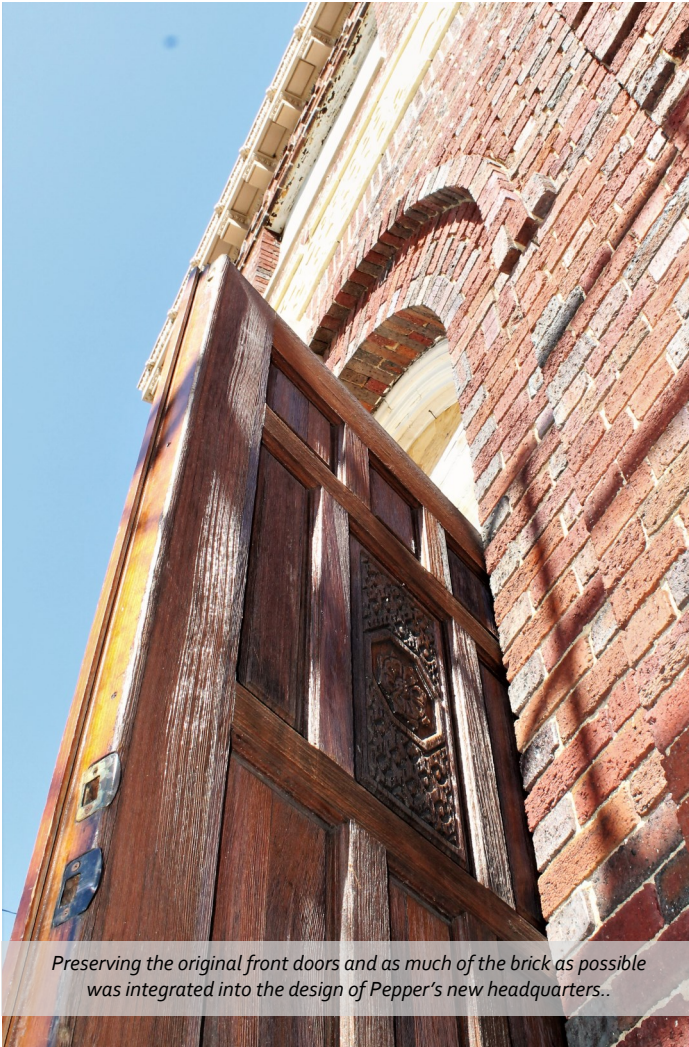
Preserving the original front doors and as much of the brick as possible was integrated into the design of Pepper's new headquarters..

- **Brick Masonry** - The exterior masonry is a consistently variegated red-purple brick in Flemish bond, but slight variations are visible in the joints and brick color. The rehabilitation includes tuckpointing a significant percentage of joints to match color, texture, and hardness of the existing masonry.

- **Doors** - One original wood exterior door on East Wyoming Avenue with 8 lights in the top.
- **Windows** - An assortment of windows, most are original with wood double-hung sashes. Historical wood interior window trim from 1912 is also throughout.

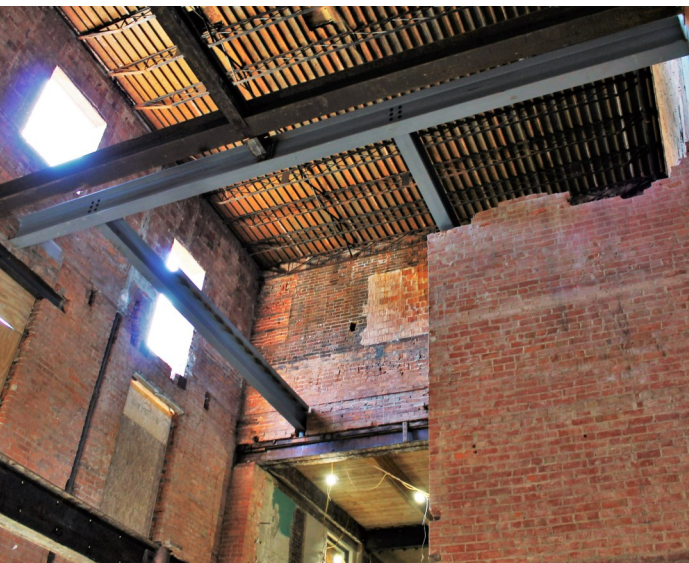
From a historical perspective, the most sensitive details to preserve are:
